CONDITIONS OF THE TANKS IN EXPLOITATION IN WHICH WILL BE MOUNTED ALUMINIUM FLOATING ROOFS

Lyubomir A. Zdravkov ¹

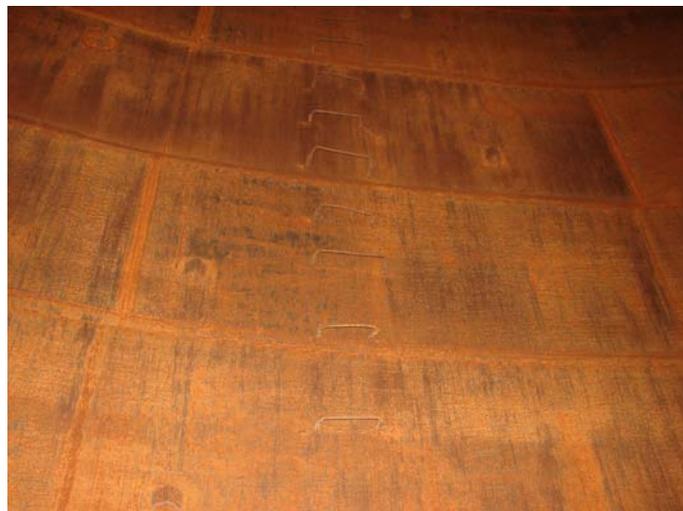
- the diameter of the shell in the first shell’s course is $D_1 = 22\,980 \text{ mm}$ and the diameter in the last, ninth course is $D_9 = 22\,870 \text{ mm}$. It shows shrinkage with more than 100 mm. Significant deviations of the shell from its cylindrical shape are not observed.
- presence of the vertical stairs in the internal side of the shell, [Fig. 2](#);

Fig. 2. Vertical stair in the internal part of the shell

- removing of the vertical stairs put in the internal side of the shell;
- removing of all mounting equipment put on the interior side of the shell - approximately $100 \div 120$ pieces in one tank;
- welding of the horizontal joints on internal side of the shell. Round the inferior edges of the joints in order to facilitate the sliding of sealing - approximately 600 m' of one tank;

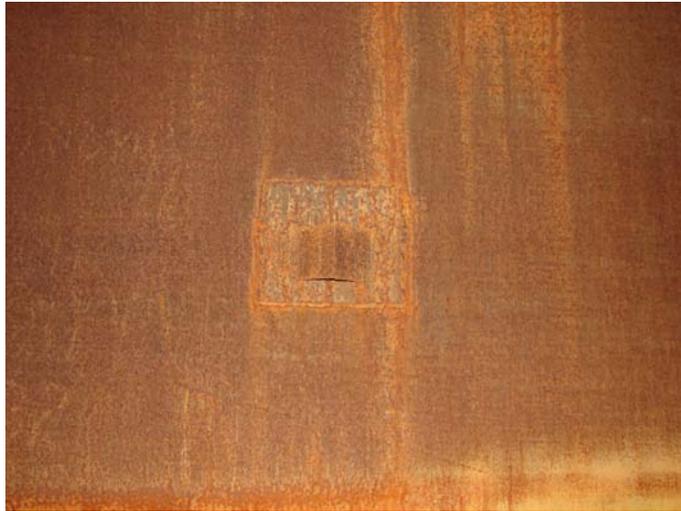
- mounting equipment on the shell are present, [Fig. 3](#) and they should be removed still mounting works;

Fig. 3. Mounting equipment on the shell which is not removed

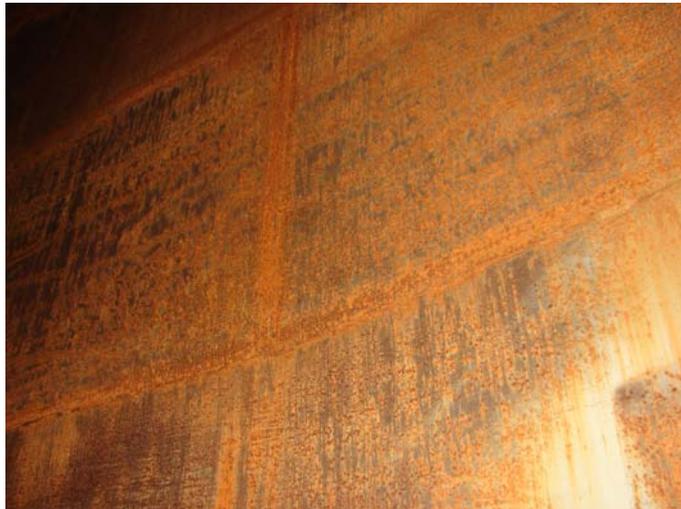
- horizontal joints on the shell are executed as lap welds, where upper course is closer to the tank centre as the lower one. There are not welds on internal side of the horizontal lap joints, **Fig. 4**;

Fig. 4. Horizontal lap joints in the shell with a single angle weld outside

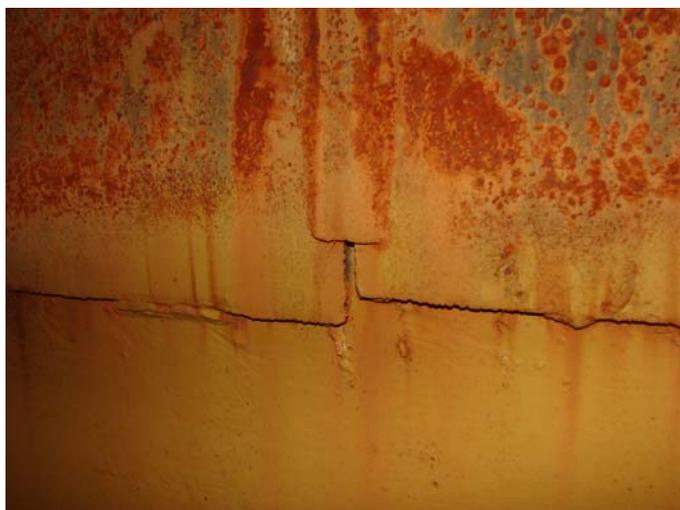
- presence of the vertical steel belts, put on the internal side of the vertical joint of the shell, **Fig. 5**.

Fig. 5. Steel belts on the vertical joints of the shell

- removing the vertical belts from the internal side of the vertical joints and welding of these vertical joints - approximately 90 m' of one tank.

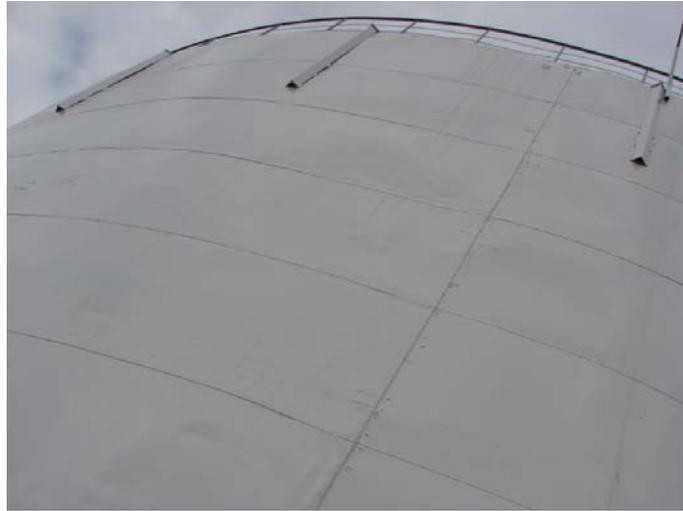
- the diameter of the shell is $D = 22\ 800$ mm as it was shown in the project. There are not considerable deviations of the shell from cylindrical shape by the project;
- vertical mounting joints are executed as a lap joints with double angular welds, Fig. 6;

Fig. 6. Vertical joint in the shell. done as lap weld

- to round the sharp edges of the vertical mounting joints.

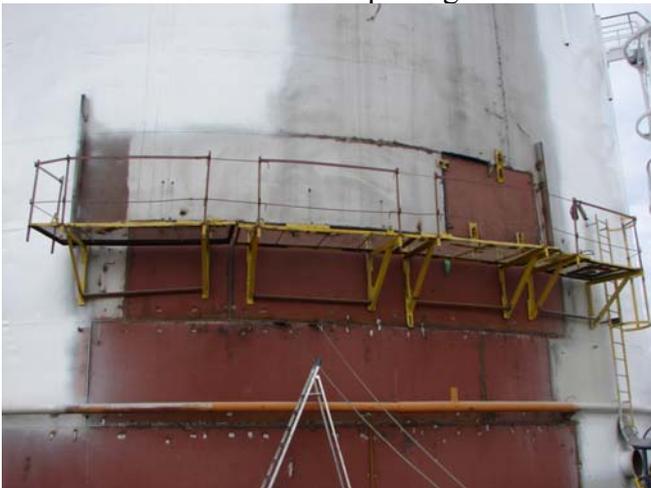
- the executed repairing works worsen their geometry instead to improve it.

Fig. 7. Replacement of sheets in the shell

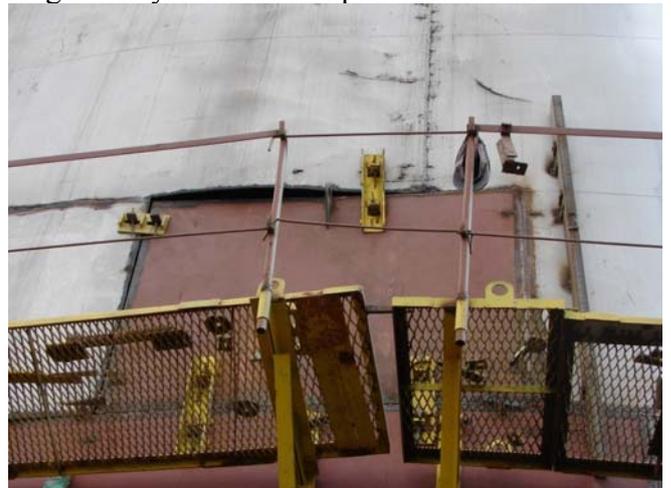
Fig. 8. Gaps between new and old sheets
