ASSESSMENT AND REHABILITATION OF THE TIMBER ROOF STRUCTURE OF THE “ASSUMPTION OF THE VIRGIN” CHURCH IN KUSTENDIL

D. Partov¹, P. Grekov², V. Kantchev³, M. Petkov⁴, R. Nikolov⁵

Keywords: timber structure, degrading factors, strengthening, wood, traditional materials

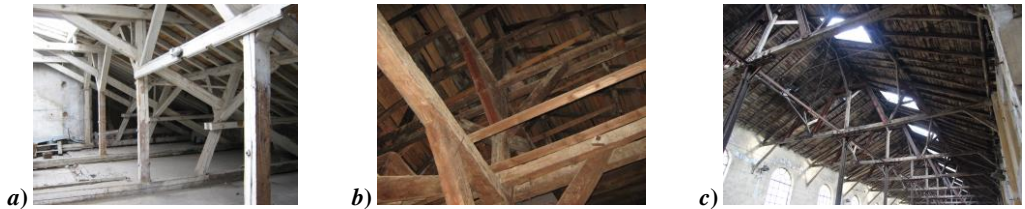
Figure 1*a,b,c*. Wood in roof construction in the civil: *a), c)* and industrial domains: *b)*

In Bulgaria, wood constructions have a vast occurrence, and an old tradition in the civil and industrial domains (Fig. 1*a,b,c*).

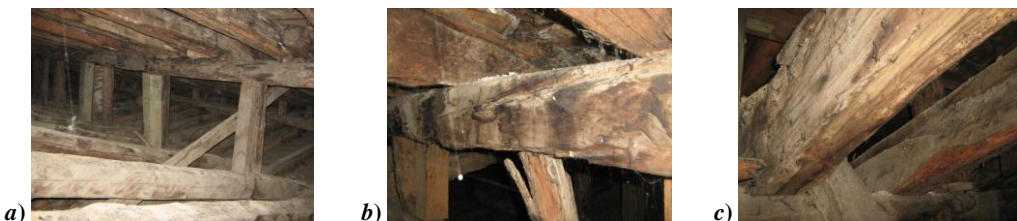
Figure 2.1a,b,c. Moisture in purlins in axis B and D

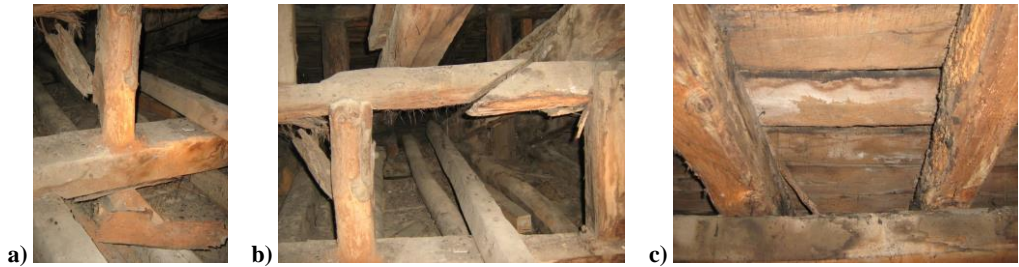
Figure 2.2a,b,c. Massive timber roof elements with different stages of wood destruction

From the *biological agents'* point of view, wood is highly susceptible to the attack of fungi and insects or, in some cases, of some marine borers [21, 24] (Fig. 2.2a,b,c).

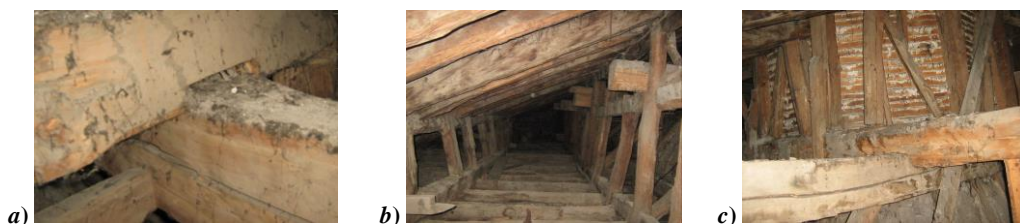
Figure 3.3a,b,c. Torsion of beam, horizontal displacement in the top of columns: a), vertical displacement of beam – caused the creep: b), and cracks in the beam: c)

The most considered *stresses* in the design of wood elements are the bending moment, tensile, compressive and shear forces. Nevertheless, there are other strength properties that are less important but that can also be used, like the torsion, creep or fatigue resistance, cracks in the horizontal elements [25] (Fig. 3.3a,b,c).

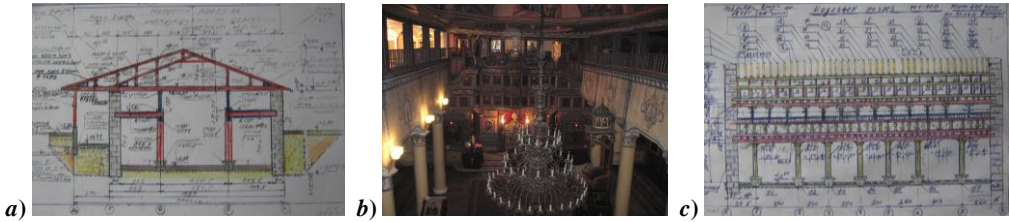
Figure 5.3a,b,c. Structures will be strengthened using steel profiles

When the damage of the beam consists in the rotting of its ends, usually caused by water absorption through the joints or from meteorological water, the degraded material can be removed and replaced with a new one or it can be strengthened using epoxy resins (Fig. 5.3a,b,c). This second procedure involves only a partial removal of the material at the ends [15]. The rehabilitation of the timber beams supports was performed through the fixation with steel triangle and steel bolts. Additional connection between roof rafters and horizontal floor beams *using steel triangle* guarantee the global behavior of the building and their correct connection to the stone masonry wall (Fig.5.4a,b,c). The extremities of the beams were treated against biotic attacks.
